Manhole Inspection Summary

Manhole # S65O__012MH

Insp Date: **4/23/08 2:25 PM**

Location Address: **1300 Bonsal St.**

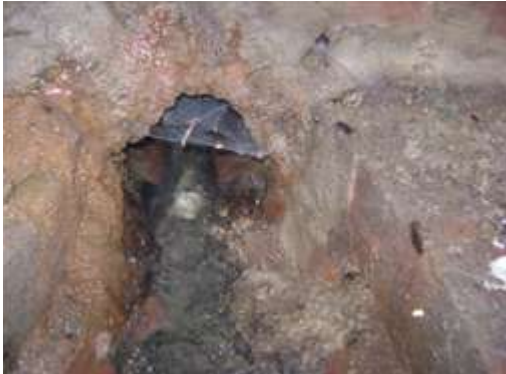
Defect 1

Comments **HEAVY MINERALS ENCRUSTED AROUND O12**

Heavy deposits encrusted on O12

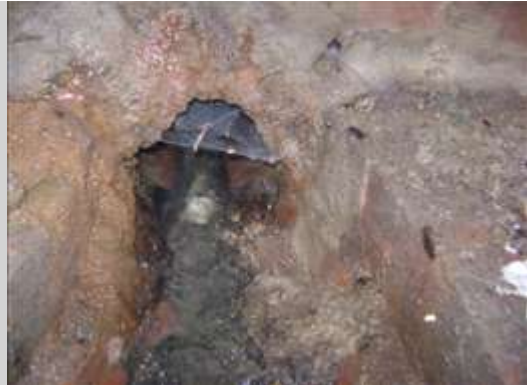
12 O'Clock Outflow

8 in. Circular Gravity Sewer
Pipe Out @ 12 O'Clock

Pipe Height: **8.4** (in.) Rod and Bar (Angled)
Pipe Material: **Clay** ☐ Pipe Lined
Invert Depth: **9.83** (ft.) Flow Characteristics: **Slow**
Deposits: ☒ None ☐ Mud ☐ Sludge ☐ Debris ☐ Grease
Silt Depth: (in.) Deposits Extent:
Infiltration: **None** Pipe Seal Cond: **Sound**

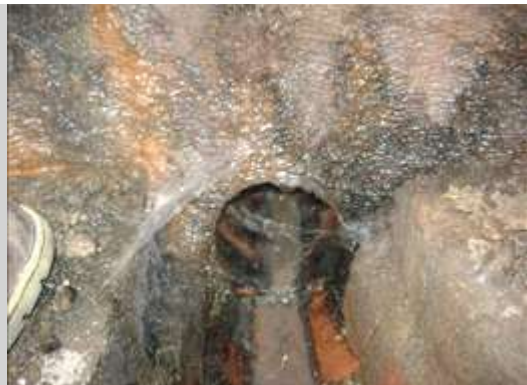
9 O'Clock Inflow

6 in. Circular Gravity Sewer
Pipe In @ 9 O'Clock

Pipe Height: **6** (in.) Rod and Bar (Angled)
Pipe Material: **Clay** ☐ Pipe Lined
Invert Depth: **9.58** (ft.) Flow Characteristics: **Slow**
Deposits: ☒ None ☐ Mud ☐ Sludge ☐ Debris ☐ Grease
Silt Depth: (in.) Deposits Extent:
Infiltration: **None** Pipe Seal Cond: **Sound**
